**AVIATION INVESTIGATION REPORT
A05O0112**

MISRIGGED ELEVATOR TRIM TABS

**FLIGHT OPTIONS LLC
RAYTHEON/HAWKER 800XP N829LX
TORONTO/LESTER B. PEARSON INTERNATIONAL
AIRPORT, ONTARIO
02 JUNE 2005**

Report Number A05O0112

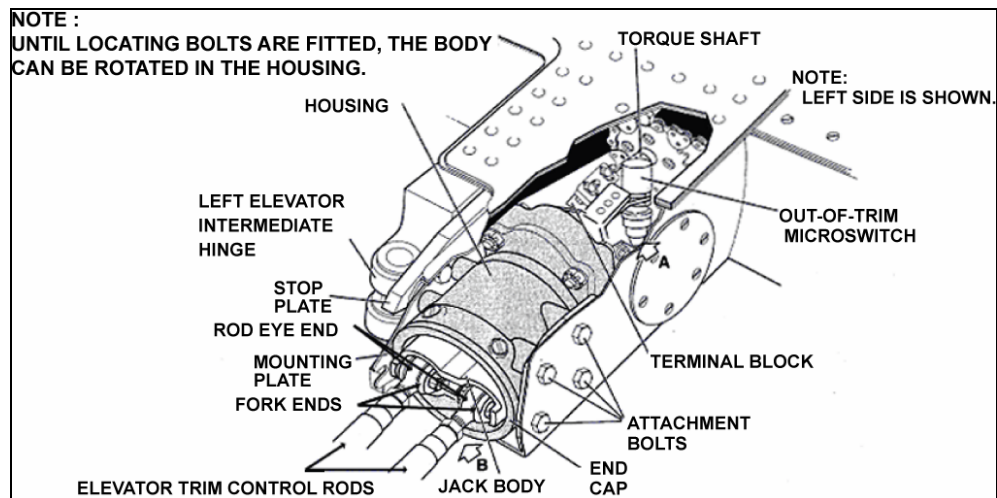
Figure 1. Elevator trim jack

Removal of the elevator trim control rods was accomplished by loosening the jam nuts at the rod eye end fitting where it attaches to the screw jack fork end and unscrewing the control rods from the eye end fitting. The senior AME removing the rods counted the number of full turns required to remove the rods and marked this number on a tag that was securely attached to each rod (Figure 1). This would later aid in the reassembly of the aircraft.

During the reassembly, the elevator trim control rods were reinstalled by screwing the control rods back onto the rod eye ends using the same number of turns as when they had been removed. The flight controls were then checked to ensure they all moved in the correct direction, and the control rods and rod eye ends were then locked accordingly. The director of maintenance carried out an independent inspection of the aircraft's affected systems, the paperwork was completed, and the aircraft was returned to service.

To check the flight control rigging, the elevator was pinned at the neutral position and the elevator trim wheel was set to 35 degrees, as per the maintenance manual. The maintenance manual, 27-30-00, Figure 504, indicated that the elevator trim tab trailing edges should fair flush with the trailing edge of the elevator when set as indicated above. However, both the left and

right trim tab trailing edges were 0.250 inches below the trailing edge of the elevator, giving the aircraft a nose-up trim condition. Next, the trim wheel was rotated to maximum nose-down trim (against the mechanical stops). When the wheel reached its stop, the trim tab's trailing edge was still slightly below the elevator's trailing edge. As such, with full nose-down trim selected, the aircraft was rigged in a nose-up condition.

1. The elevator trim tabs were not rigged in accordance with the aircraft maintenance manual, resulting in a misrigged condition and a lack of sufficient nose-down trim authority.

- amended its quality assurance program to ensure closer scrutiny in all aspects of maintenance than was previously possible;
- implemented a process for regular discussions on process control;
- implemented the process of a full control-travel check before disassembly; consequently, this process revealed that many aircraft received to work on had controls not rigged within the specified limits;
- implemented additional training on human factors, improving the reporting of potential problems; and
- the company is in the process of implementing a Safety Management System (SMS).
